High-rise retrofit

Updating 40-year-old boiler system proves a challenge

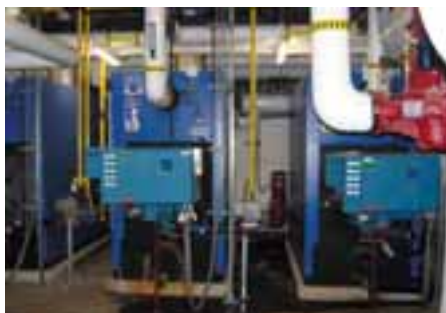
A much-needed boiler upgrade revealed other problems.

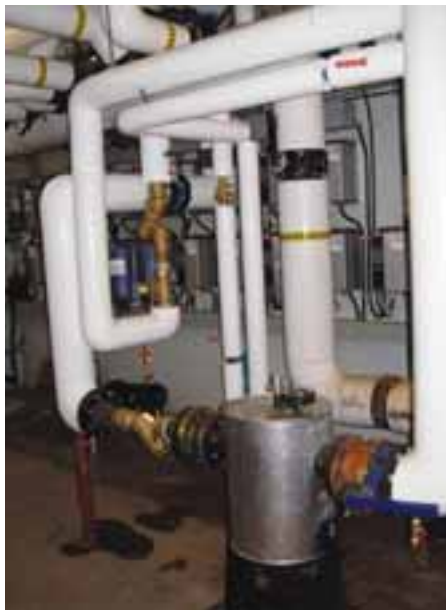
This European-made magnetic sludge separator provided a cure.

And that's when the problems began. Abrasive black sludge from the existing iron piping was destroying pump seals. The installation of particle filters did little to alleviate the issue because the particles were so fine that they flowed right through, reported De Faveri. Seals in just about every pump had to be replaced, something that technicians from Superior were still working on during P&HVAC's visit.

The key piece of equipment turned out to be the sludge separator. Made in Germany by Judo Water Treatment, it is specifically designed to deal with magnetic sludge. The Judo Ferroclean houses four high performance magnets rated for a 50-year lifespan. They attract the iron sludge (or magnetite). Each magnet is housed inside a sleeve. A raw water connection is attached to a valve at the top of the unit and there is a drain on the bottom. To clean, the magnets are pulled down out of the water stream, allowing the sludge to be backwashed away from the sleeves, which remain in place, explained John Priolo, president of Judo Water Treatment Inc., Concord, Ont. An integrated magnesium anode rod provides additional protection by chemically removing unwanted oxygen.

The water is pre-filtered through a 10-micron Judo Heifi-Top backflush filter to remove the larger particles and air bubbles. Backwashing occurs through turning a hand-wheel at the bottom of the filter 180 degrees. This closes the inlet, reverses the flow, and activates stainless steel bristles that dislodge any particulate. Air bubbles are vented through the top.

Both units are mounted on a "side-stream" four-inch piping layout. As a result, no bypass is required and it is not necessary to shut down the system for

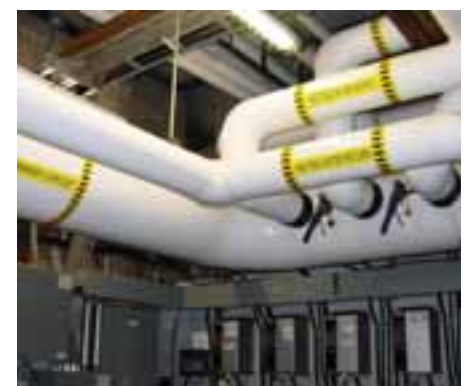
Pipe fitting as fine art – note the variable speed pump drives below.

When Weinstein re-designed the heating system, it proved an ideal application for injection mixing. A large custom-built header in each building supplies five zones, each an individual closed loop system. There are 33 pumps in the system, ranging from fractional to 15 horsepower. Each is controlled by a variable speed drive, making field adjustment easy. Return piping enters the manifolds at 45 degrees to ensure water goes smoothly into the header rather than bouncing off the back wall of the header and re-circulating to other zones, explained Weinstein.
